CONSIDERATIONS FOR DESIGNING THE OUTER DIAMETER OF FFRP LINERS IN PIPE REHABILITATION

By Aaron Homing Ni

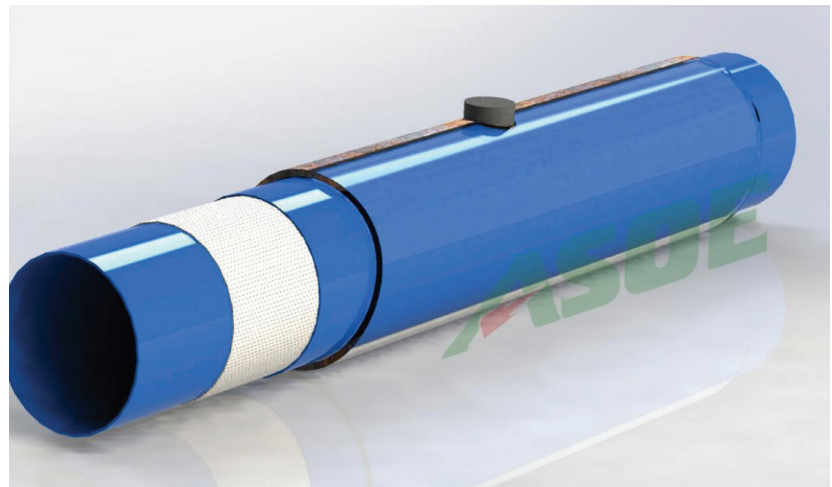
FIGURE 1. CLOSE FIT LINER

The primary objective when selecting an FFRP liner OD is to ensure a close fit between the liner and the host pipe under operating pressure. Achieving a snug fit is crucial as it eliminates the presence of an annular space or gap between the liner and the host pipe to prevent long term effect to the liner. Eg:

Closed-fit lining is preferred due to its superior structural integrity, leak prevention, improved flow capacity, reduce contamination risk and long term performance benefits.

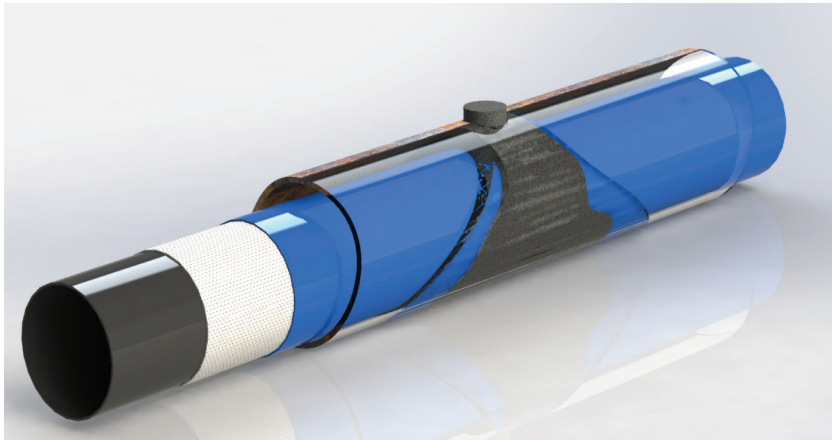
FIGURE 2. NON-CLOSED-FIT LINER

Firstly, if smaller OD liners, such as 450mm, 454mm, or 460mm, are installed, an annular space is created. This gap becomes an entry point for water, earth, and sand to infiltrate the host pipe through leaking holes. In cases where the water supply is temporarily terminated, vacuum pressure can develop within the pipeline. If the vacuum pressure reaches a significant level, the FFRP liner may collapse temporarily, leading to further sand and earth ingress. Subsequent resumption of water supply causes the water within the annular space to be squeezed out, but the sand and earth remain, accumulating

Requirement Three: Grouting or patch rehabilitation is necessary to close the leaking holes/cracks if annular space between host pipe and liner exist

Owners must choose FFRP liners that can closely fit the inner wall of the host pipe when subjected to operating pressure. If owners install FFRP liners with ODs of 450mm, 454mm, or 460mm, it will result in the formation of an annular space. This space provides an entry point for water, earth, and sand to infiltrate the host pipes through leaking

remain trapped. If water supply disruptions occur repeatedly, the accumulation of sand and earth will progressively increase, exerting infinite pressure on the liner (as shown in the provided image). This accumulation can cause the FFRP liner to become choked, necessitating pipe rehabilitation. Additionally, when the FFRP liner closely fits the inner wall of the host pipes, it minimizes the reduction in the liner's inner diameter (ID), ensuring maximum water flow. This close fit is crucial for maintaining optimal hydraulic performance. The range of OD options provided by companies like ASOE allows owner to make an informed decision that caters to the specific requirements of their pipe rehabilitation projects

Without closed-fit, all leaking holes/cracks should be closed by grouting or other patch rehabilitation techniques. Closing leaking holes/cracks is to stop soil infiltration. In fact, in many scenarios it is impossible to close the leaking holes or cracks of the host pipes underground or rivers. For example, if water pipes under river contains leaking holes, it is difficult or impossible to stop water and mud infiltration by grouting or patch rehabilitation techniques.
